SERVICE MANUAL

SECTION I

The
HYDRAULIC SYSTEM
of the
1948 CONVERTIBLE

September 1947
Packard Motor Car Company
Detroit 32, Michigan

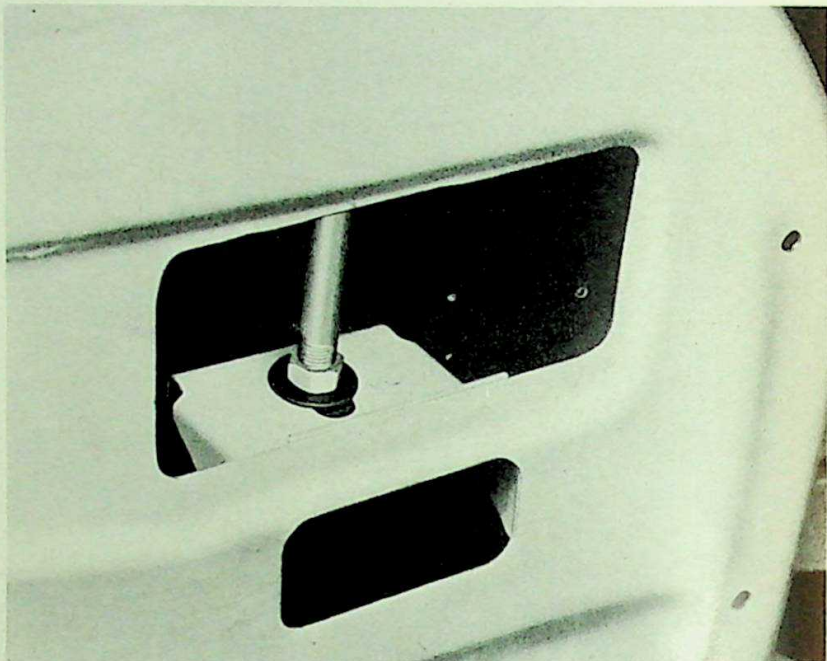
Fig. 3—Window Wing Front Support Shaft Locking Nuts Are Accessible Through Openings Shown.

sible through the openings shown in figure 3. Also loosen the three retaining screws of the channel shown in figure 4. The complete window wing and door window channel assembly then can be shifted to obtain proper fore and aft door window alignment.

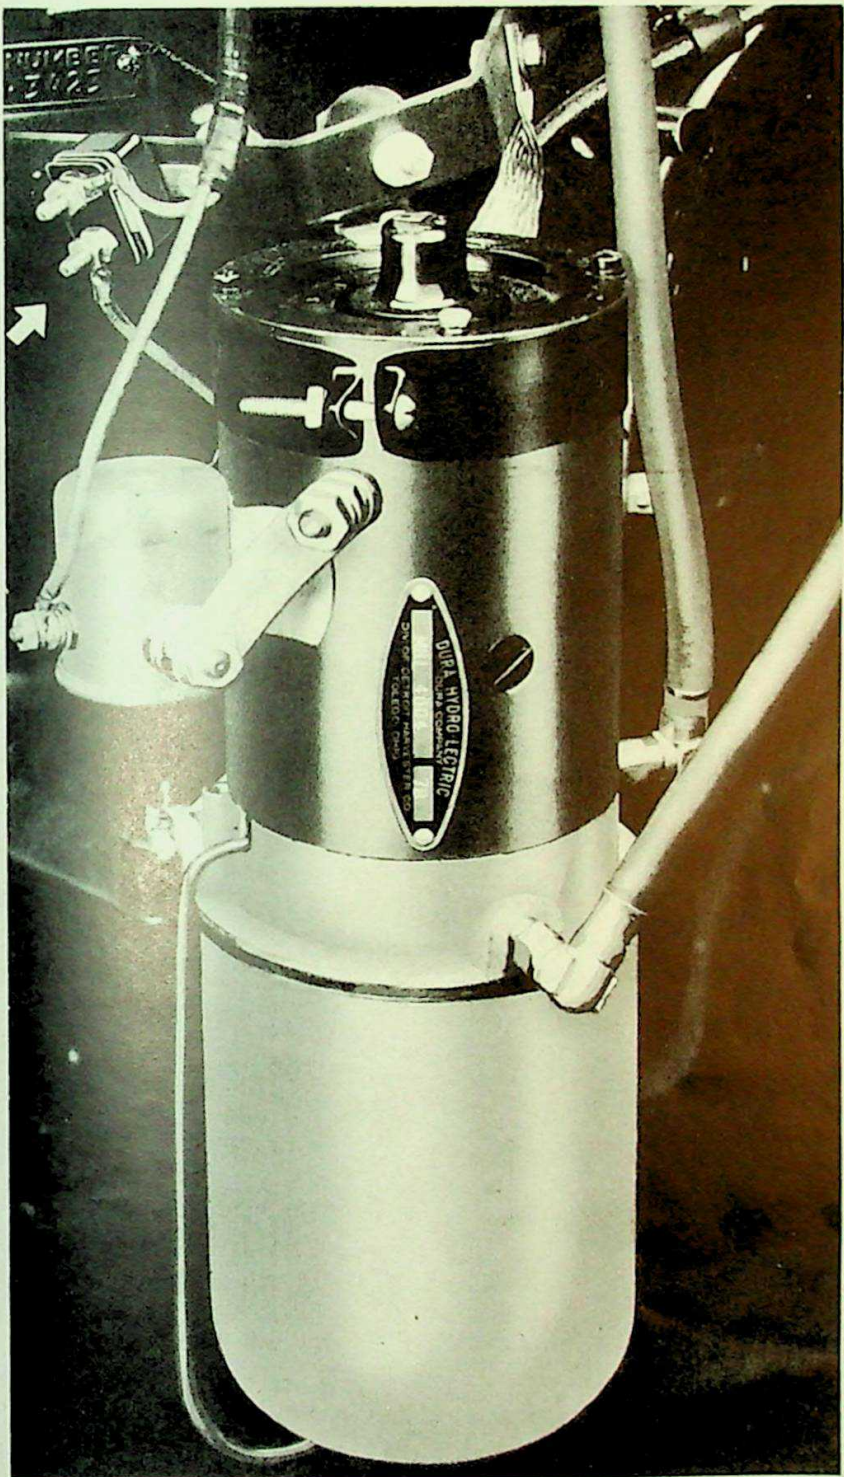
Fig. 10—Circuit Breaker on Pump Upper Bracket Guards Against Short Circuit Damage.

A defective circuit breaker will make the entire system inoperative. When this condition exists, short across the two terminal posts of the circuit breaker and operate one of the windows. If the window operates normally, the circuit breaker should be replaced.
